NATIONAL TRANSPORTATION SAFETY BOARD
Investigative Hearing

Amtrak Passenger Train 501 Derailment
DuPont, Washington
December 18, 2017

RRD18MR001

Crashworthiness and Survival Factors

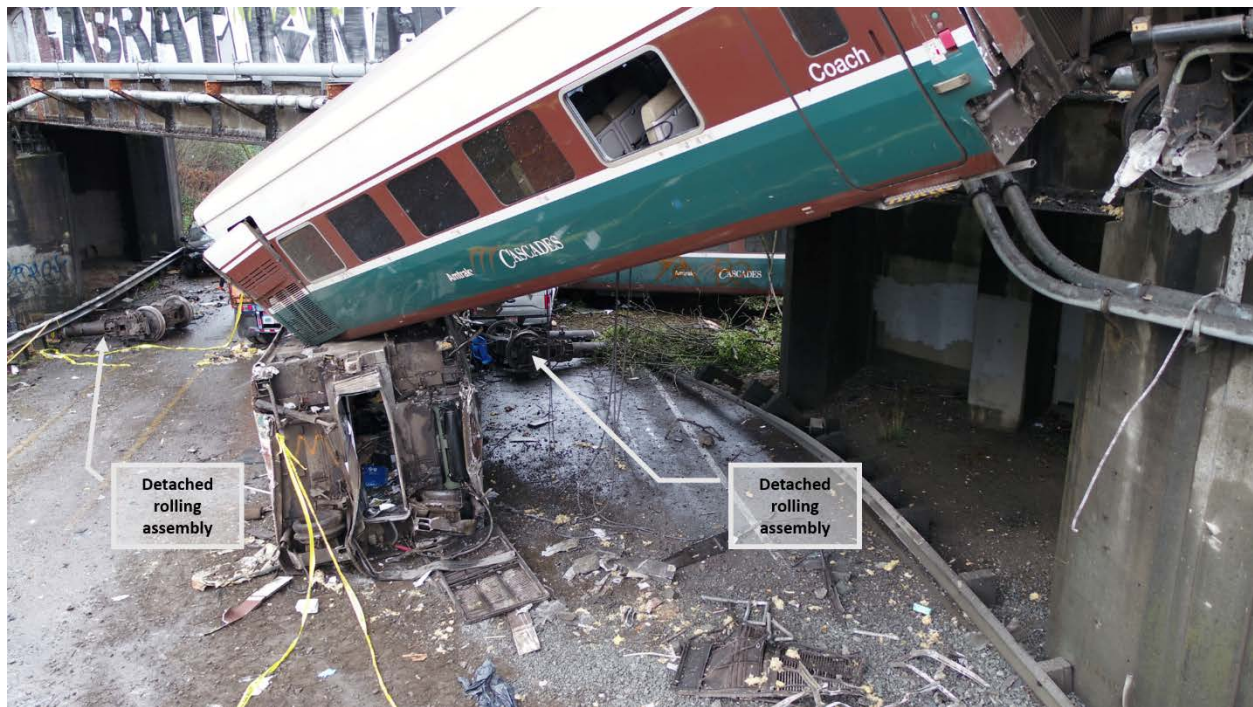
Rolling assemblies are located at the leading end (oriented relative to the direction of travel) of the 12-semi-permanently coupled cars. The rolling assembly from AMTK 7424 was located underneath the bridge next to the left guardrail on the south lanes of Interstate 5. The rolling assembly from AMTK 7421 was located behind a Ford pickup truck on the south lanes of Interstate 5. The specific details of each rolling assembly are described later in this report. (See figure 2.)

Figure 2. AMTK 7421 resting on AMTK 7424, detached rolling assemblies indicated. (Photo WSP)

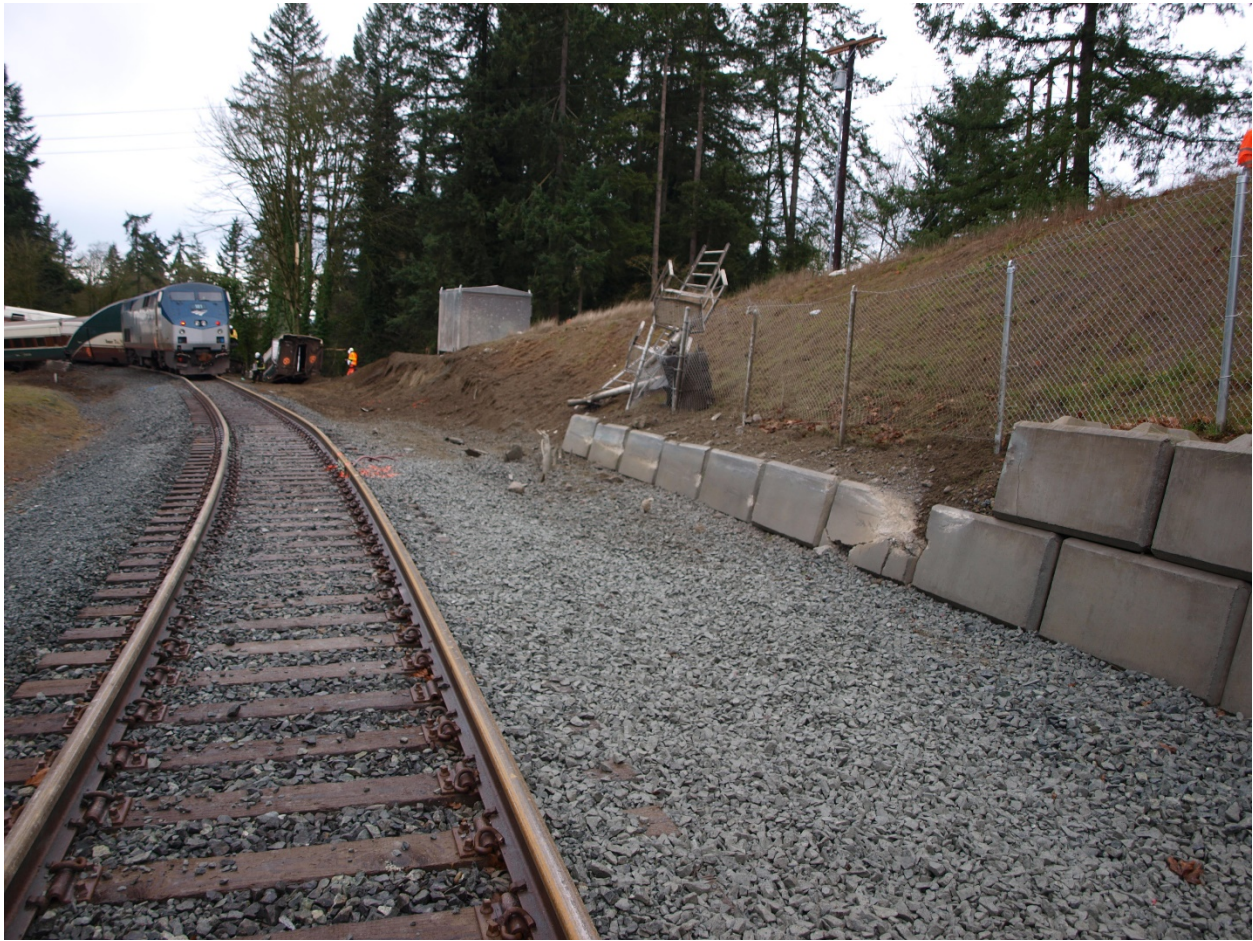
Damage to the concrete wall to the right of the track and the signal post at the POD are consistent with the train colliding with these wayside structures.

Figure 3. Concrete wall adjacent to track near the POD.

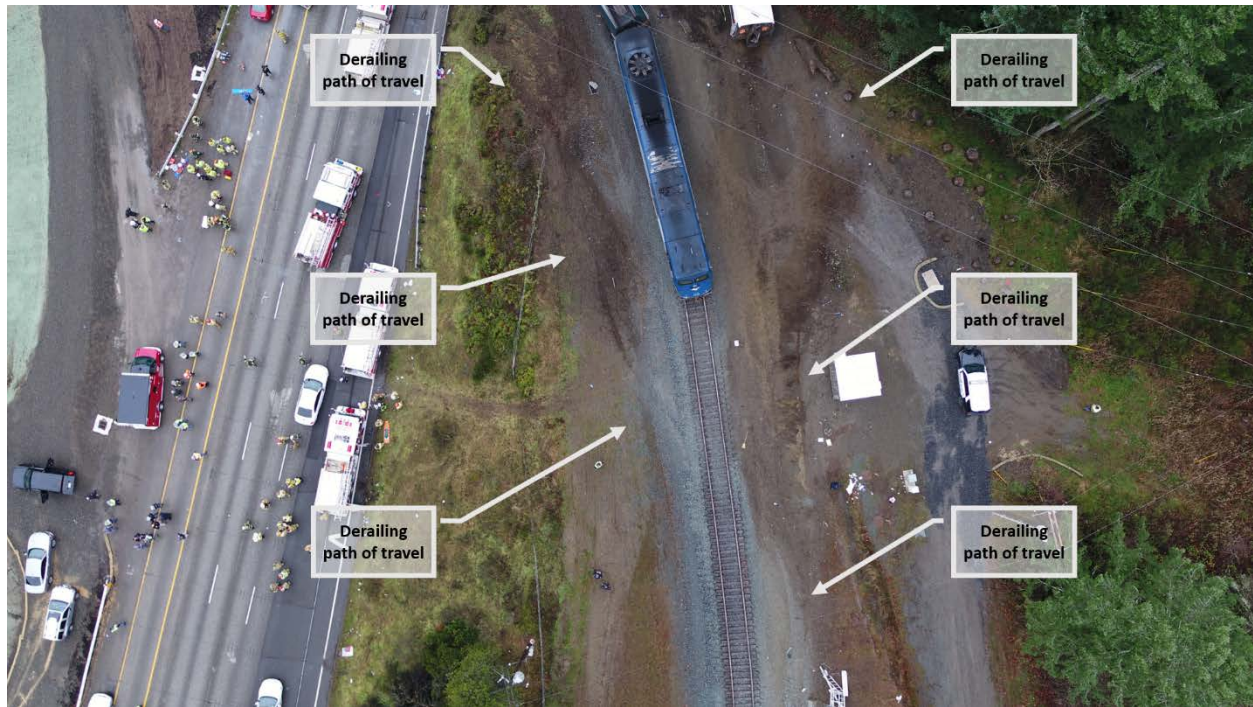
The cars trailing behind AMTK 7504 then traveled to the left of the main track. In the aerial photograph below witness marks visible in the ballast and soil clearly show the path of travel of the train. See figure 4.

Figure 4. Derailing path of travel of Amtrak 501. (Photo WSP)

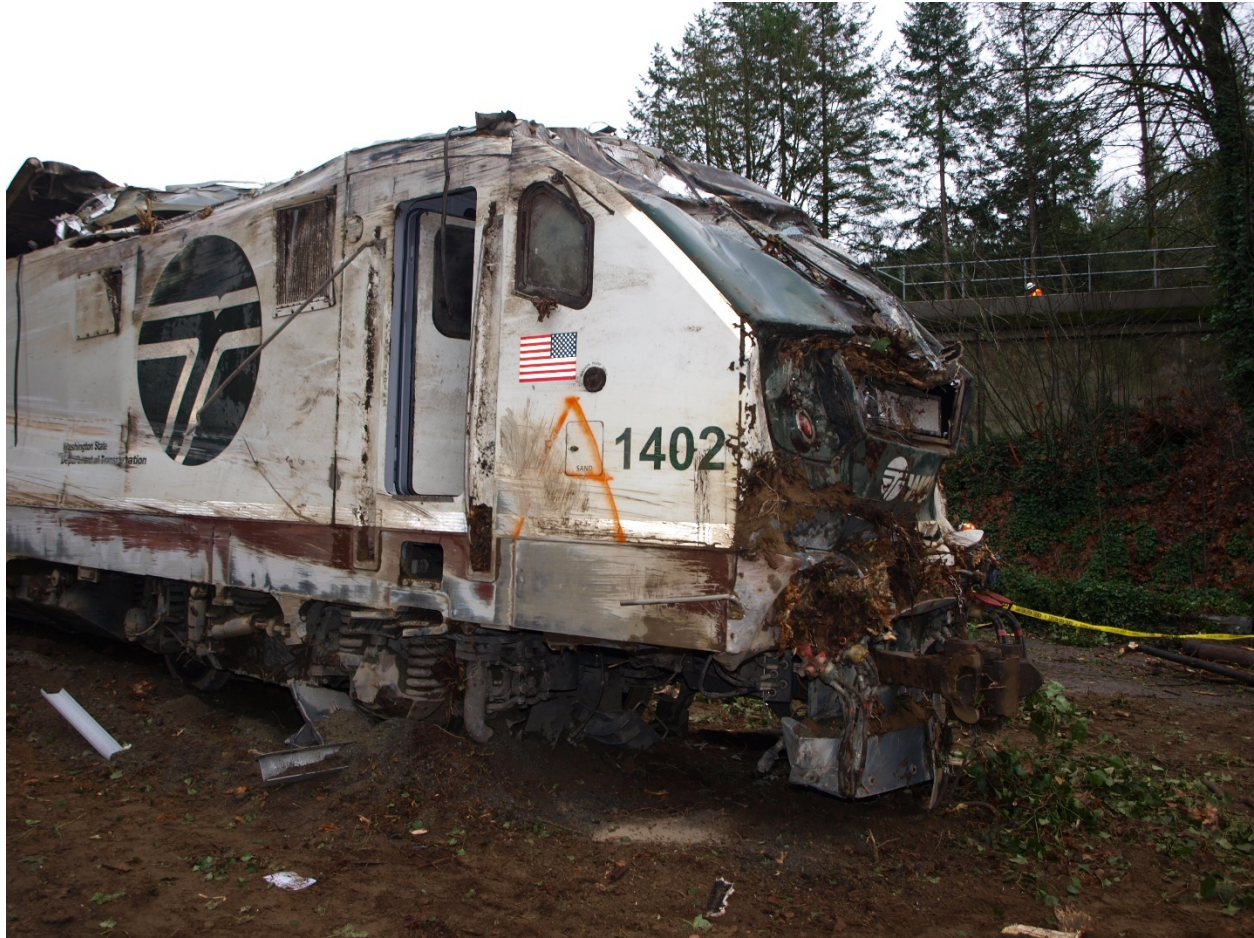
The lead locomotive, WDTX 1402, received impacts to the front top section of the cab. The cab roof deformed into the operator's compartment about 13-inches. The roof panels sheared off exposing the machine room compartments. The right side of locomotive exhibited horizontal scrape marks along its full length and mud, dirt, wood and rocks were lodged into the side panels, consistent with the locomotive proceeding through the woods on its side. The locomotive came to rest about 457-feet from the POD, on the interstate, upright and forward facing, indicating it righted itself as it moved through the wooded area impacting the adjacent trees and passing through the highway guardrail, which was located beneath the locomotive.

Figure 5. WDTX 1402 Post derailment position.

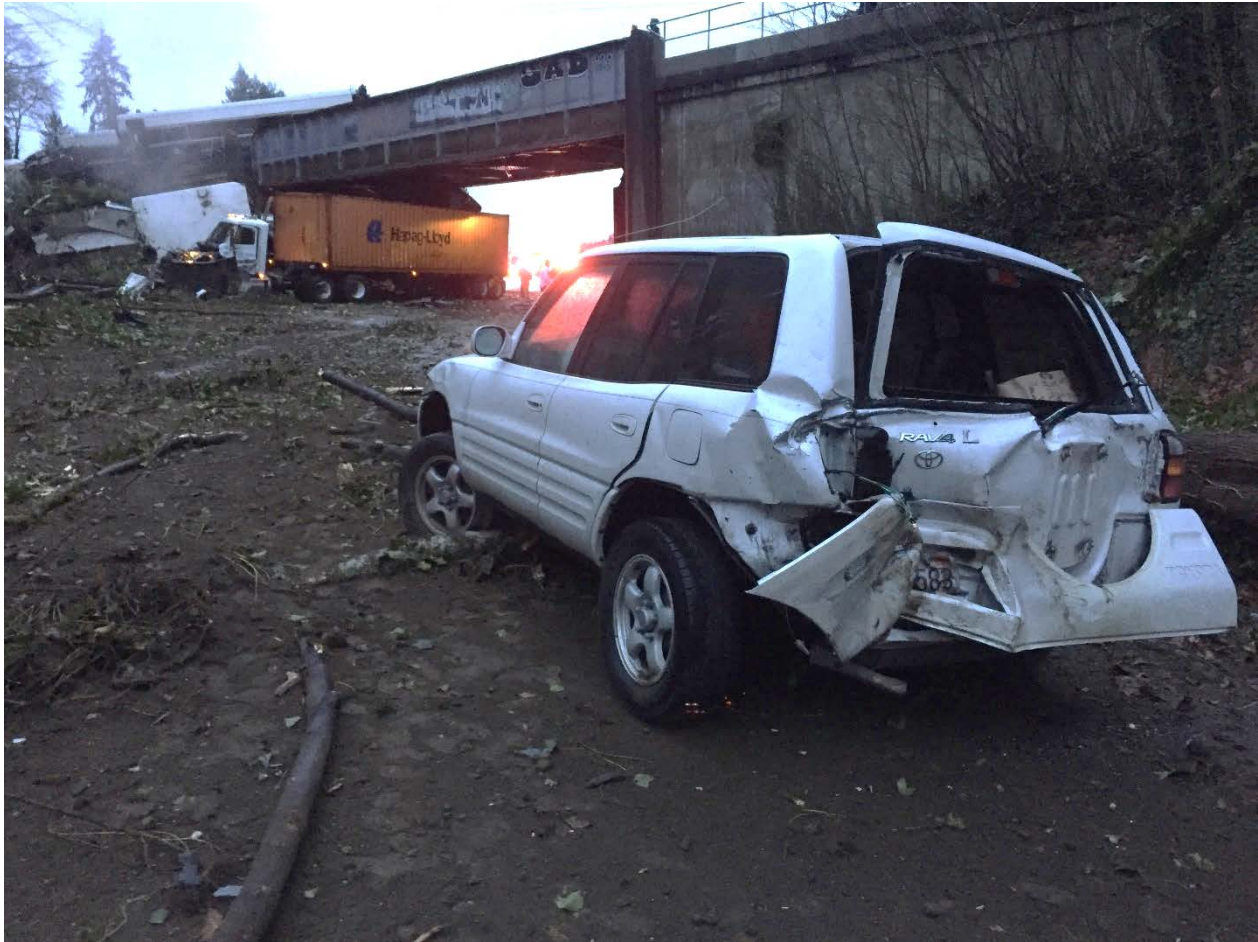
During interviews with highway vehicle operators, a driver of a white Toyota RAV4 said she was traveling southbound in the right lane when her vehicle was struck from behind by the locomotive. The vehicle came to rest on the left side of the roadway, facing north in the southbound lane.

Figure 6. Photograph of highway vehicle struck by lead locomotive. (Photo provided by driver.)

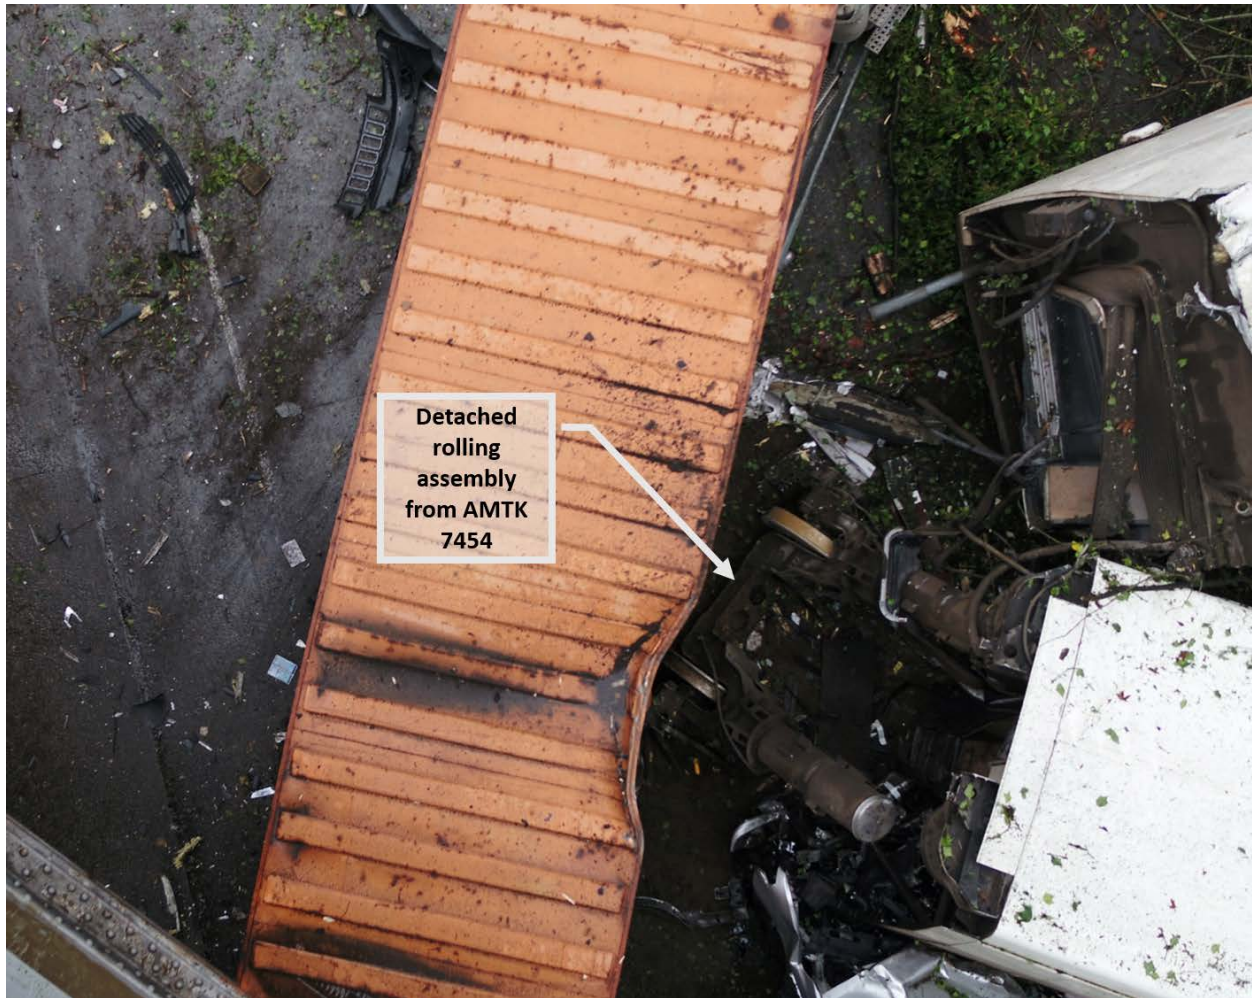
between the end wall structure of AMTK 7554 and AMTK 7454. Further details of the articulated coupler connections can be found in section 1.5.3.3 of this report. The rolling assembly from AMTK 7454 separated from its attachments, however, the assembly remained near the supported end of this car.

Figure 7. Detached rolling assembly from AMTK 7454. (Photo WSP)

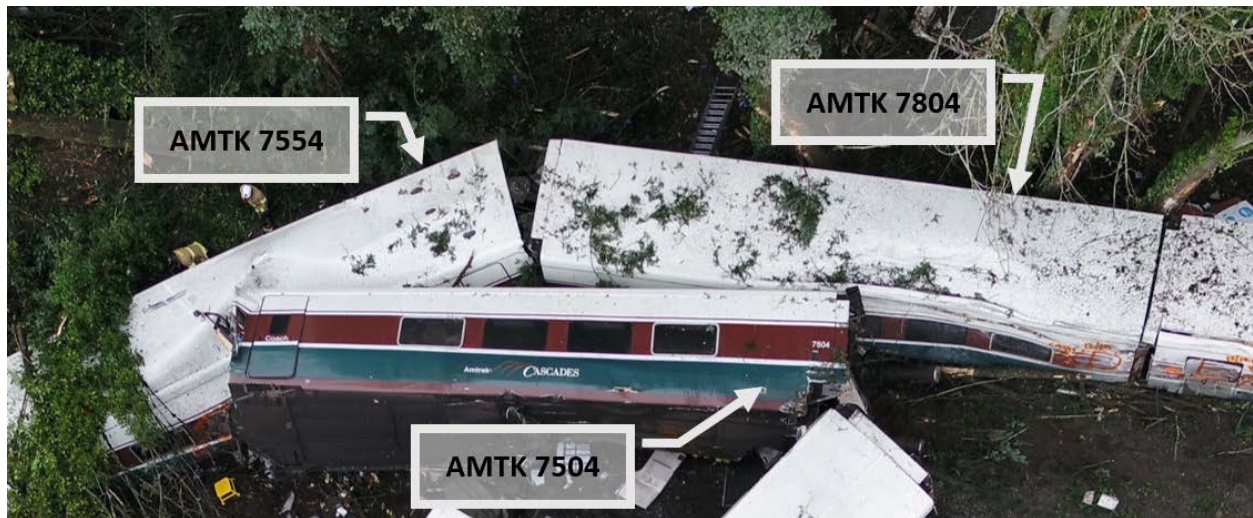
AMTK 7554 came to rest upright in the woods remaining coupled to and aligned with AMTK 7454. AMTK 7504, the sixth car, was positioned on its left side against the roof of AMTK 7554 and AMTK 7804. The damage of AMTK 7554's roof structure is associated with the impact from AMTK 7504.

Figure 8. AMTK 7504 resting on AMTK 7554 and AMTK 7804. (Photo WSP)

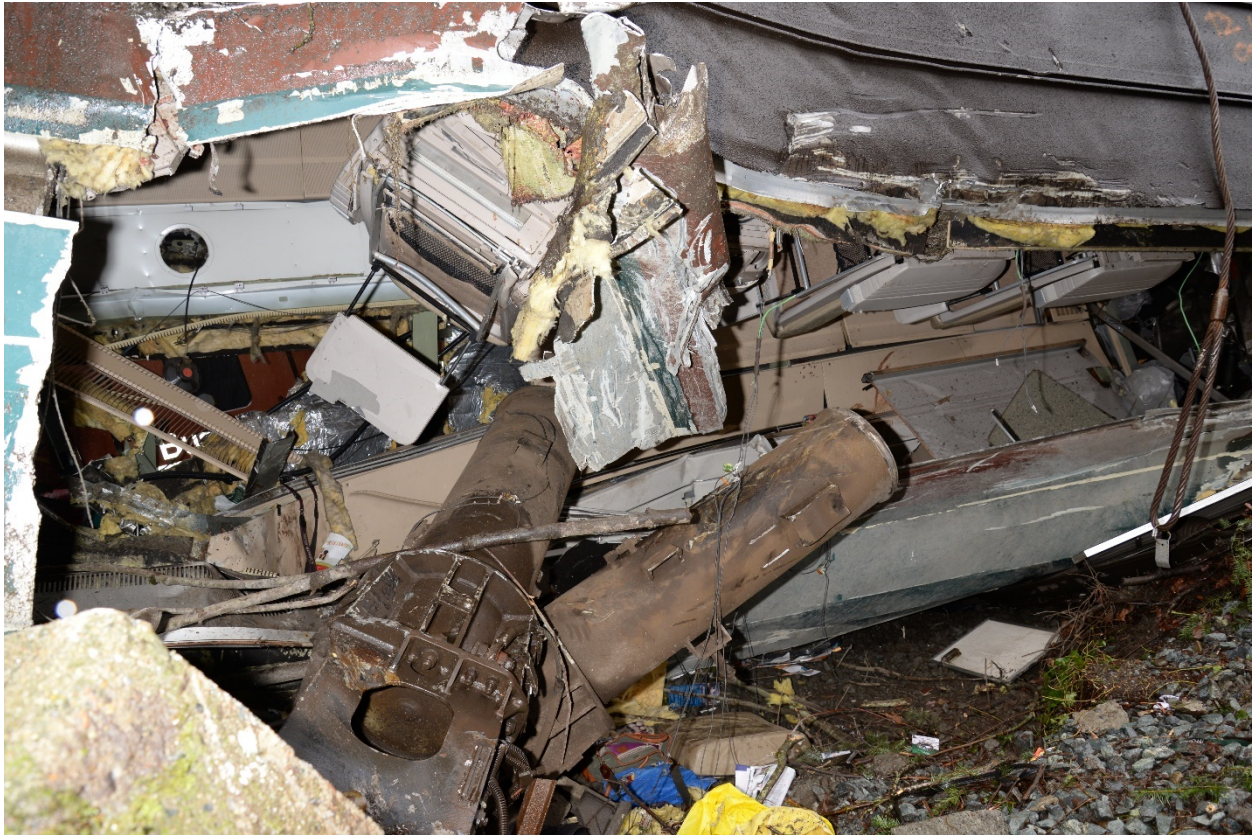
At its point of rest, AMTK 7504's left side wall was buckled and bowed inward. The entire car bowed inward, and the underframe plastically deformed in a manner consistent with a twisting motion. Laying partially within the left side compromised wall structure of AMTK 7504 was a complete rolling assembly severely deformed (twisted) as shown in figure 9.

Figure 9. Detached rolling assembly against AMTK 7504 (looking north). (Photo WSP)

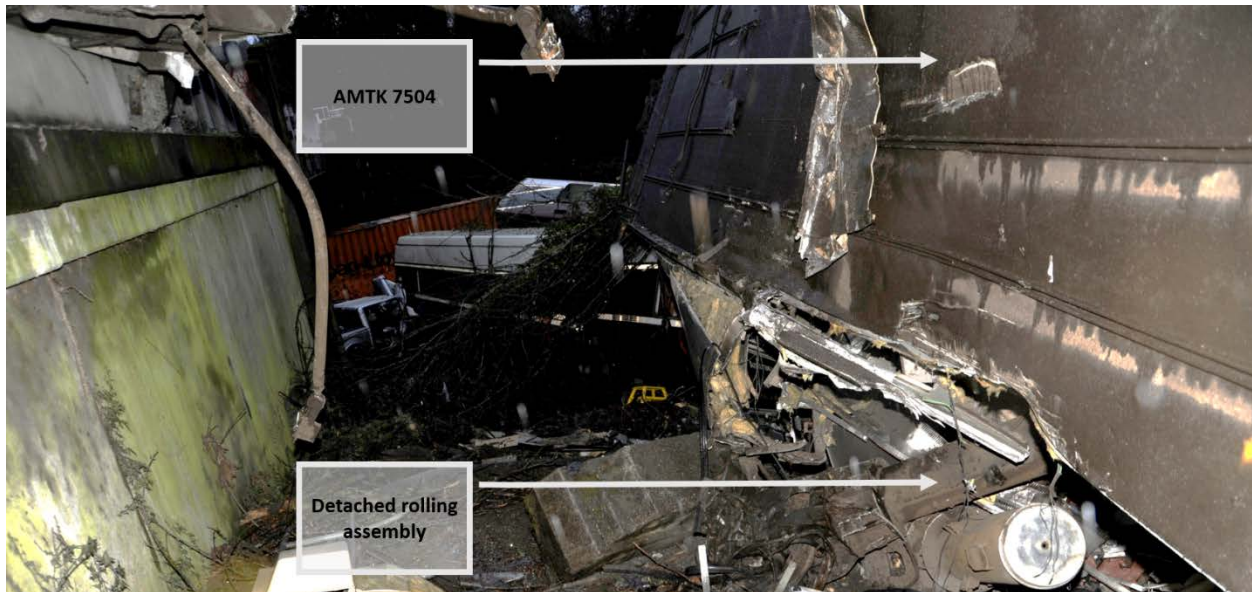
The towers of the severely twisted and deformed rolling assembly are typically parallel. The wheels of the rolling assembly lay immediately outside of the deformed left side of AMTK 7504. One of the towers of the rolling assembly was partially resting within the passenger compartment against occupied areas within the car. Post-accident observations showed that two of the three deceased passengers in this car came in contact with the rolling assembly at its point of rest. Investigators determined the rolling assembly was from car AMTK 7422. (See figure 10.)

Figure 10. Detached rolling assembly against AMTK 7504 (looking west.) (Photo FBI)

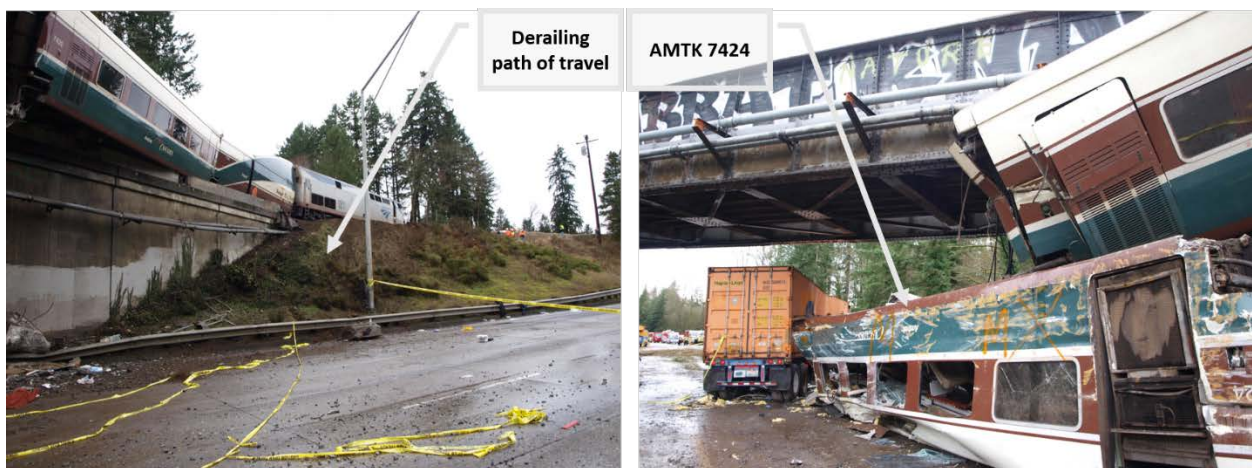
AMTK 7424 came to rest on the southbound lanes of Interstate 5 beneath the bridge, on its roof and rotated opposite its original direction of travel. AMTK 7424 was originally coupled to the rear end of AMTK 7504. During the derailment, AMTK 7424 separated from AMTK 7404 and derailed to the left of the main track. This oriented AMTK 7424 toward the left side of the bridge, where a steep embankment descends to the Interstate. (See figure 11.)

Figure 11. Derailling path of AMTK 7424. (Photos WSP)

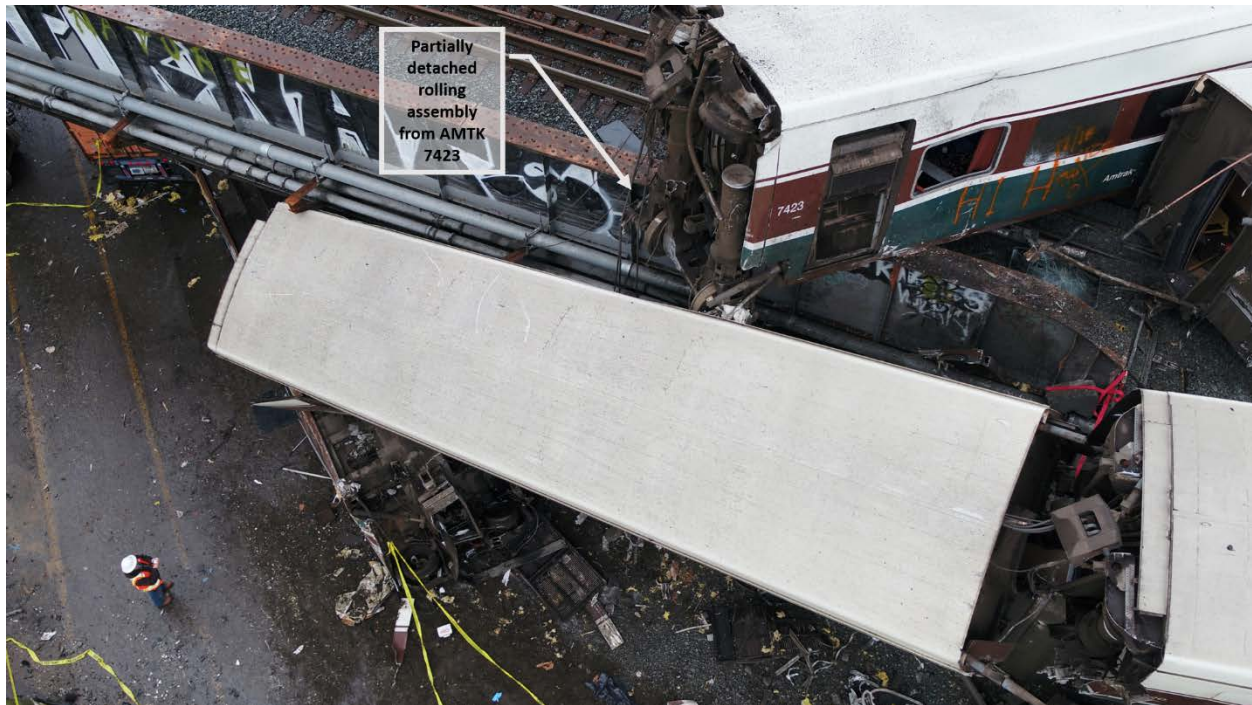
AMTK 7423 came to rest upright on the bridge positioned across the track, orientated about 50° counterclockwise to the track. The articulated connection between AMTK 7423 and AMTK 7422 failed. The rolling assembly from AMTK 7423 remained near the car but was partially detached. The wheels of the rolling assembly compromised the sidewall of AMTK 7421.

Figure 12. AMTK 7423 partially detached rolling assembly. (Photo WSP)

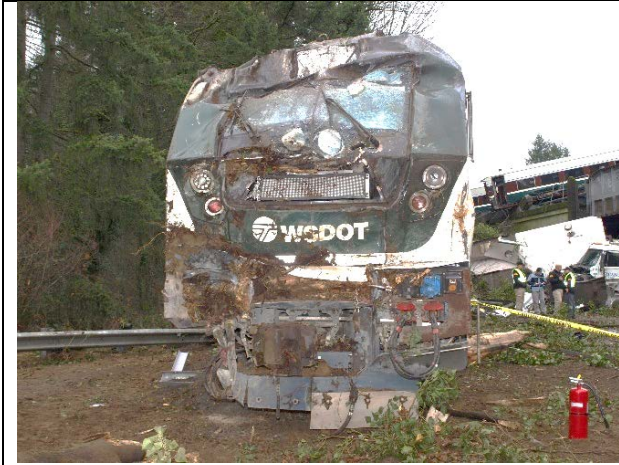
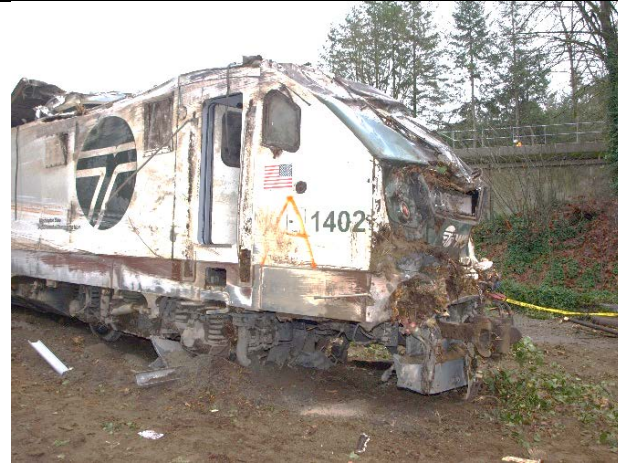
During the on-scene phase of the investigation, investigators observed localized post collision deformations to the front of the operating cab above the corner and collision posts. The operating cab windshield was destroyed; however, the laminated safety glass feature prevented the shattered glass from separation into pieces. The right side of the locomotive exhibited non-structurally compromising sidewall damage consistent with the locomotive being on its side. Abrasions were visible along the entire length, from the side sill (lower portion along the floor line) to the roof. The rear end wall structure was severely loaded during the derailment and was separated from the right side wall connections. The left side connections remained intact. Damage along the left side was minimal. The roof panels (three total) were severed from their connections.

Figure 14. Front of WDTX 1402.

Figure 15. Right side of WDTX 1402.

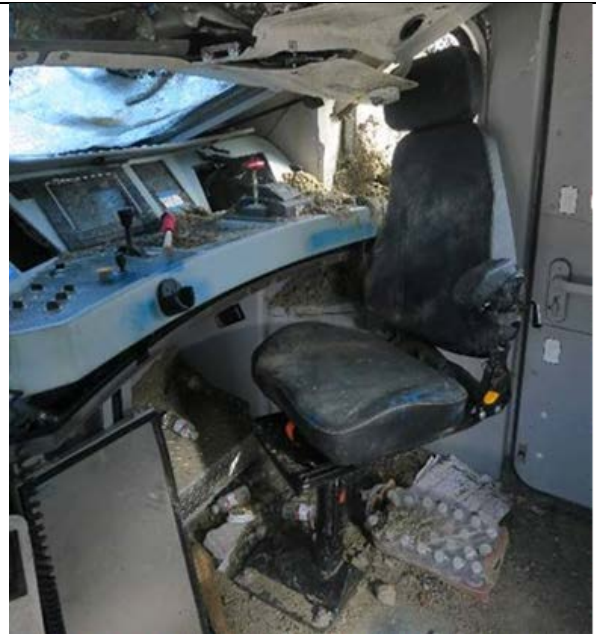
The damage to interior of the operating cab was constrained primarily to the leading end, most notably at and above the front glazing (windshield). The vertical space of the cab interior was reduced to approximately 19-inches between the operator's desk and the ceiling, and to 66-inches from the floor to the ceiling. The height above the seats was reduced by 13-inches from originally 79.5-inches. All doors, both side doors and the machinery room access door, were fully functional after the crash. The cab ceiling emergency exit hatch was dislodged from the vehicle. The hatch is comprised of two parts. The upper, or outer, part came to rest in the wooded area between the track and the interstate and the inner portion was inside the cab. Investigators estimated the locomotive lost about 5% of its occupied volume in the cab.

Figure 17. Photograph of the damaged locomotive cab.

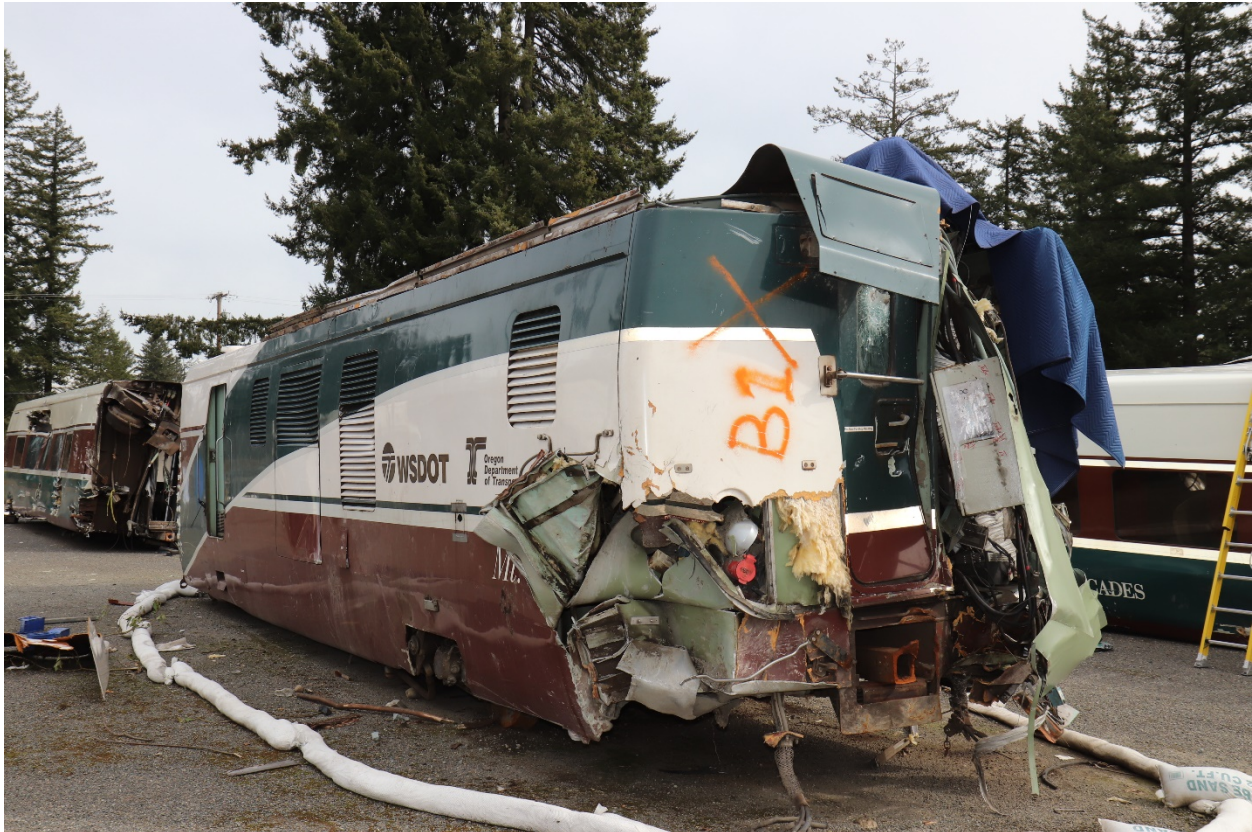
The exterior side structure of the of the power car [right and left] was relatively intact and was not substantially damaged. The sides were scraped and exhibited impact marks that did not compromise the sidewall structure. The leading end of the power car was damaged as a result from interactions with the locomotive however, the collision posts of this vehicle showed no signs of separation. The leading end right side wall was torn about 4.5-feet toward the rear end of the car. The leading end left side wall was torn about 3-feet toward the rear end of the car. The top upper right and left ‘fin’ assemblies were not present during this examination although the mounting brackets were. [Post-accident review of at-rest photos reveal the fins were in place, thus their removal occurred during the recovery.]

Figure 26. AMTK 7903 leading end.

The front coupler assembly was fractured, deformed upward and slightly twisted in the counter-clockwise direction when observing from the front. This car has a tank for water and a tank for diesel fuel with filling locations on each side of the car. The fuel fill caps on each side are missing and 265 gallons of diesel fuel spilled on to the ground during the derailment.

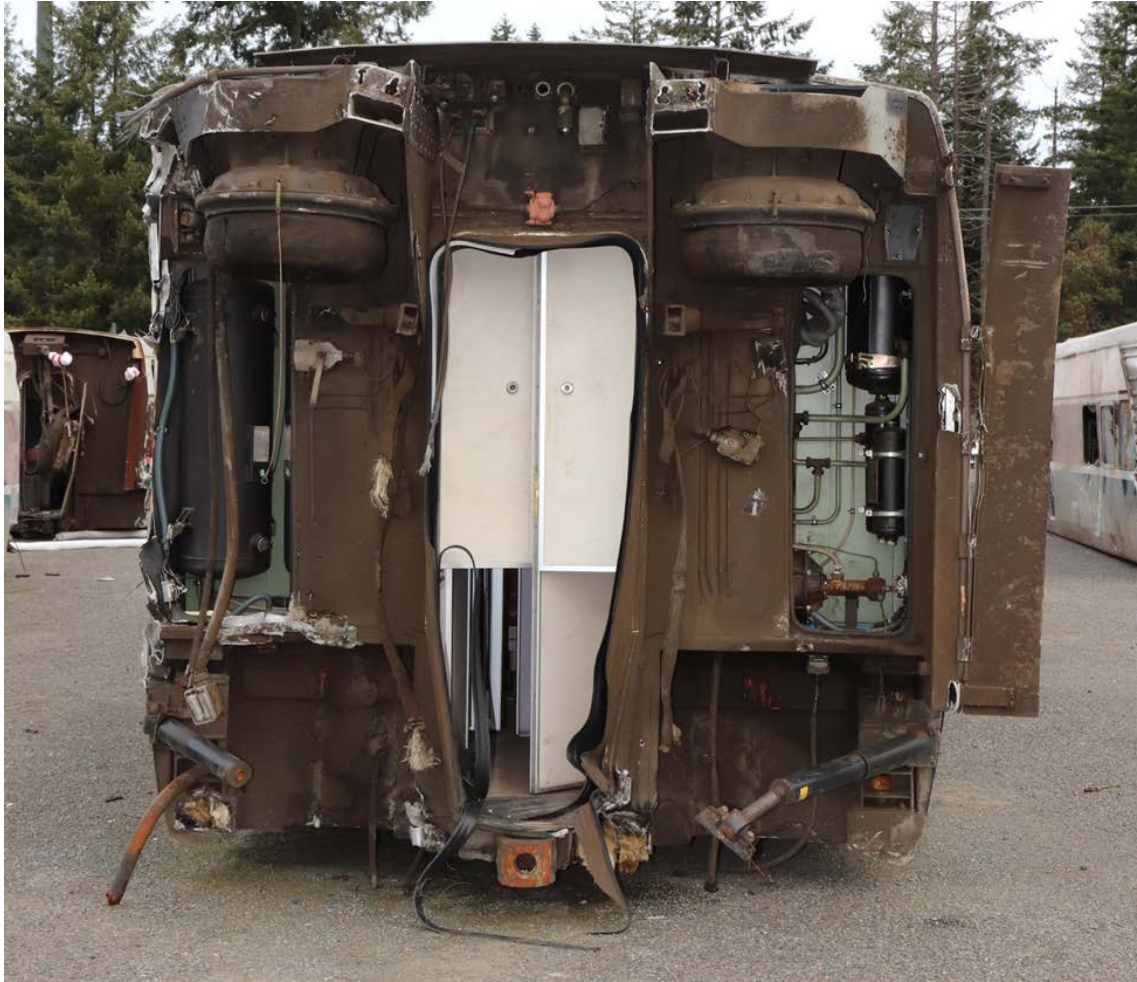
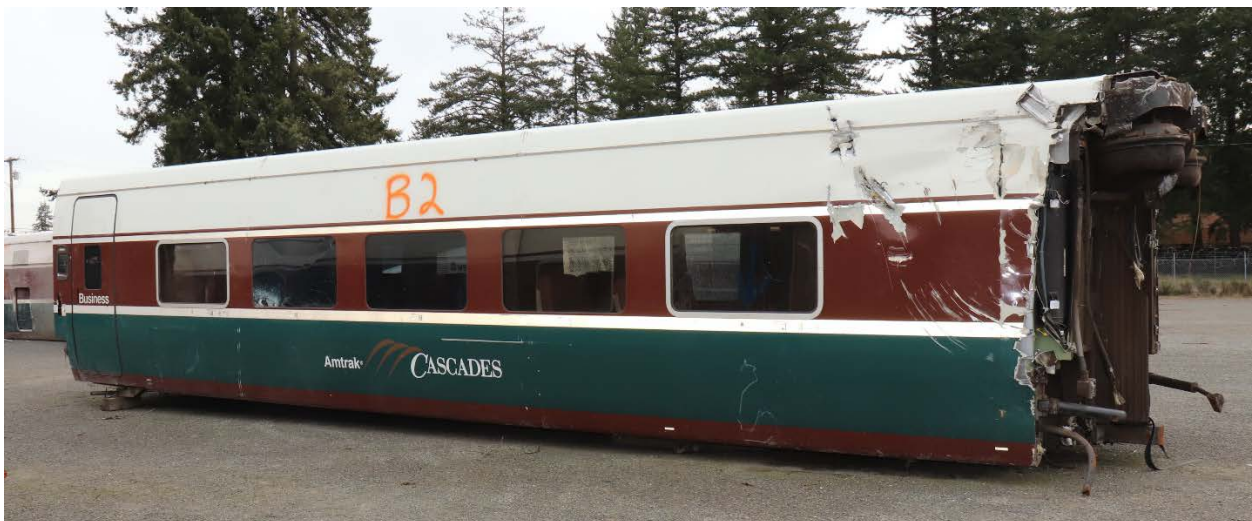
The exterior side structure of the business class car [right and left] was relatively intact and its structure was not substantially damaged. The rolling assembly detached during the derailment and was not observed in place during this examination. Examination of the guidance bars showed indications of overstress and deformation. The articulated connection between AMTK 7454 and AMTK 7903 was severed because of the derailment. When observed, the supported end showed indications of longitudinal loading. The upper left air spring remained in place. The primary steel rolling assembly support cables on the right and left side were broken. The tower straps were broken on the right and left side. The weight bearer supports on the supported end were torn from their mounts. The weight bearer bars on the right and left side of the suspended end were torch cut. The articulated joint on the trailing end remained intact during the derailment and was observed to be torch cut for this examination.

Figure 27. AMTK 7454 Supported end.

Figure 28. AMTK 7454 Right side.

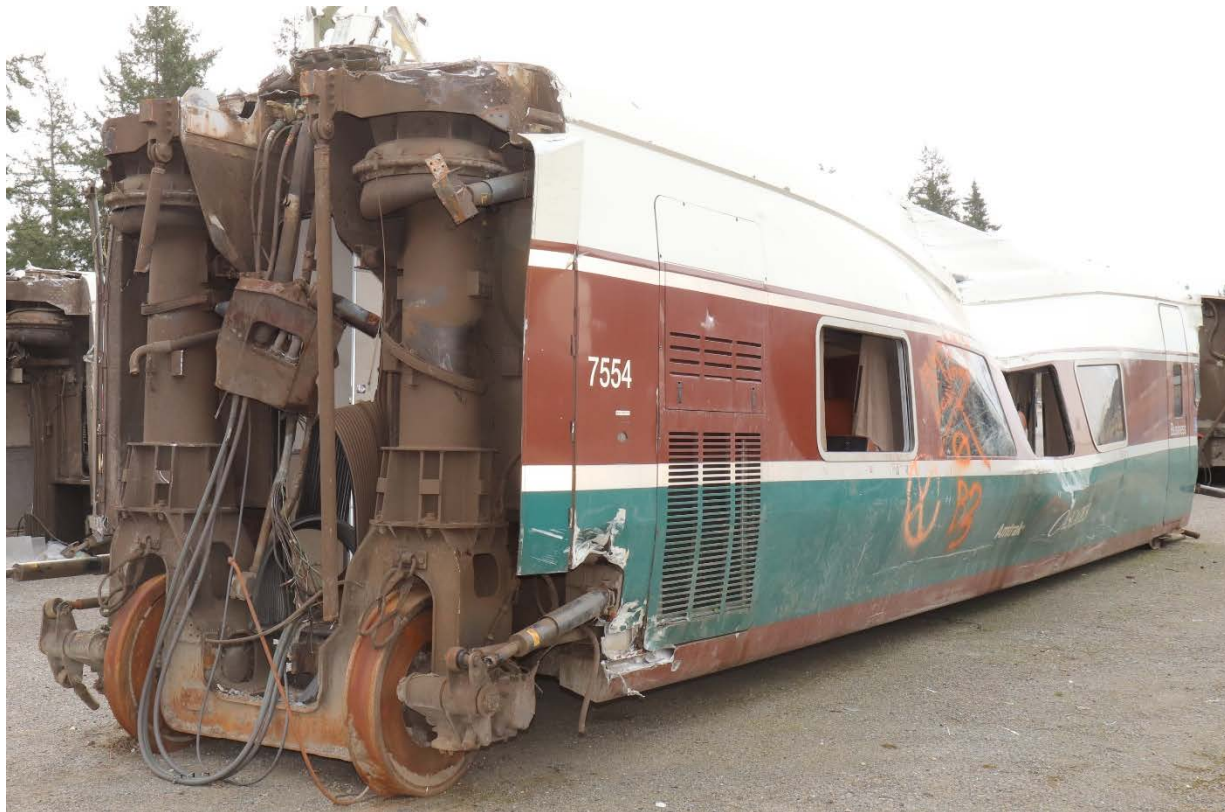
The supported end of this vehicle retained the wheel assembly and all safety cables and straps throughout the crash sequence. The articulated connection remained intact with AMTK 7454. The exterior right-side structure was relatively intact. There were several indications of a raking collision along the roofline. The left-side structure was crushed inward above the passenger window line at the midpoint of the car. The total loss of occupied volume is estimated at 10%. The supported end rolling assembly was attached during this examination. The primary cable attachment cables were intact, and the tower straps were intact. The weight bearer bars at the supported ends were torch cut, the mounting brackets were intact. The upper right and left steering links were slightly deformed but intact. Investigators noted the right upper steering link jam nut was not engaged. The link exhibited signs of oxidation. See figure 30. The lower steering links were torch cut. The car to car connection (articulated joint) was torch cut.

Figure 29. AMTK 7554 Supported with rolling assembly end and left side.

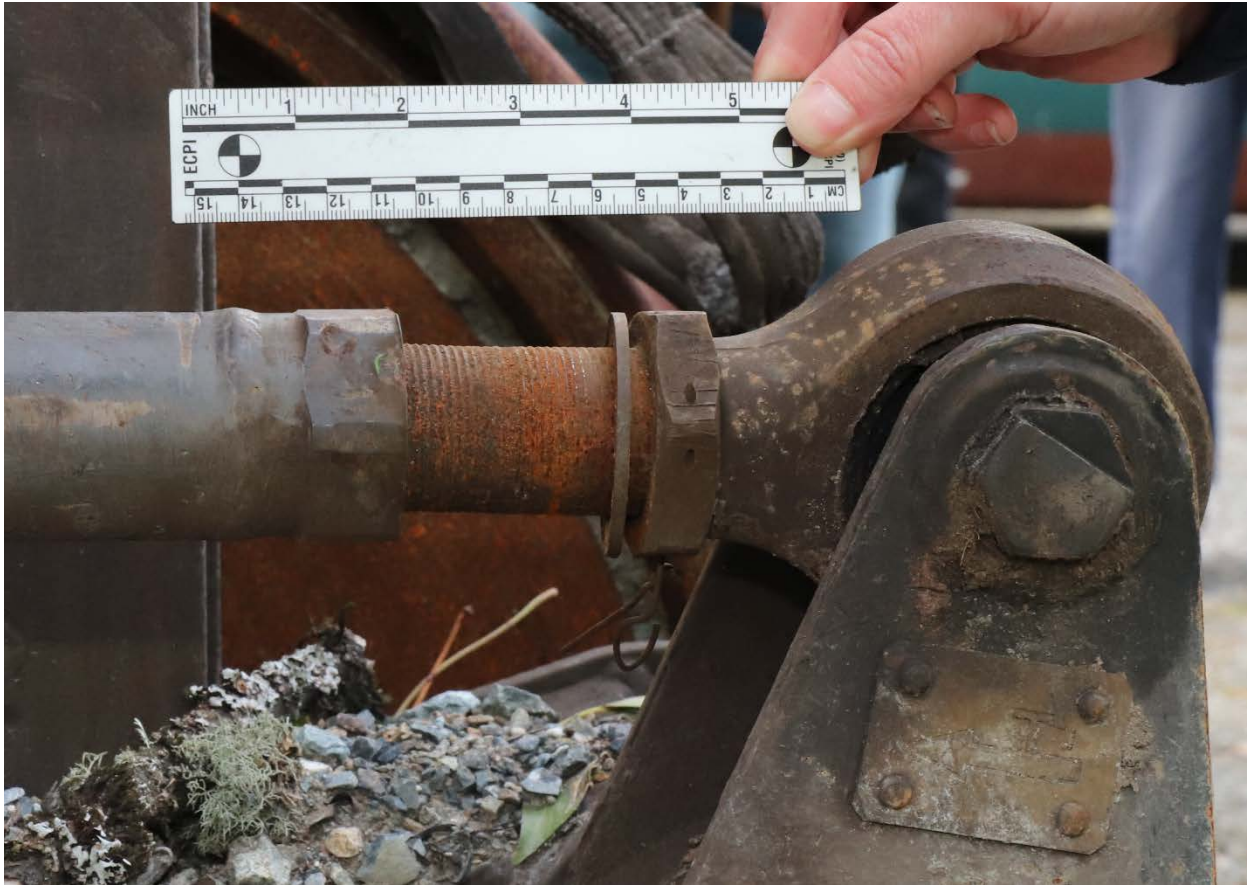
Figure 30. AMTK 7554 right upper steering link jam nut not engaged and oxidized.

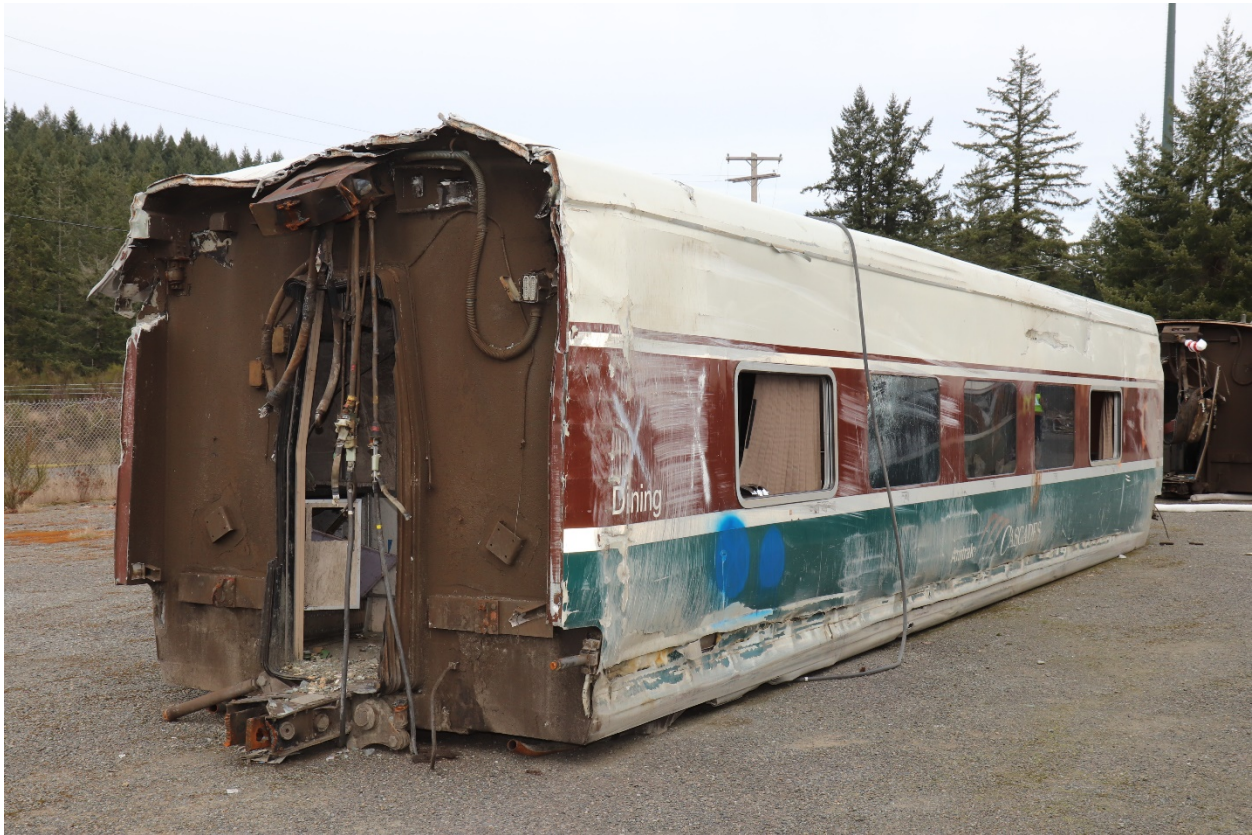
with AMTK 7303 remained intact during the derailment and the connection was observed to have been torch cut during this examination.

Figure 31. AMTK 7804 Suspended end and right side.

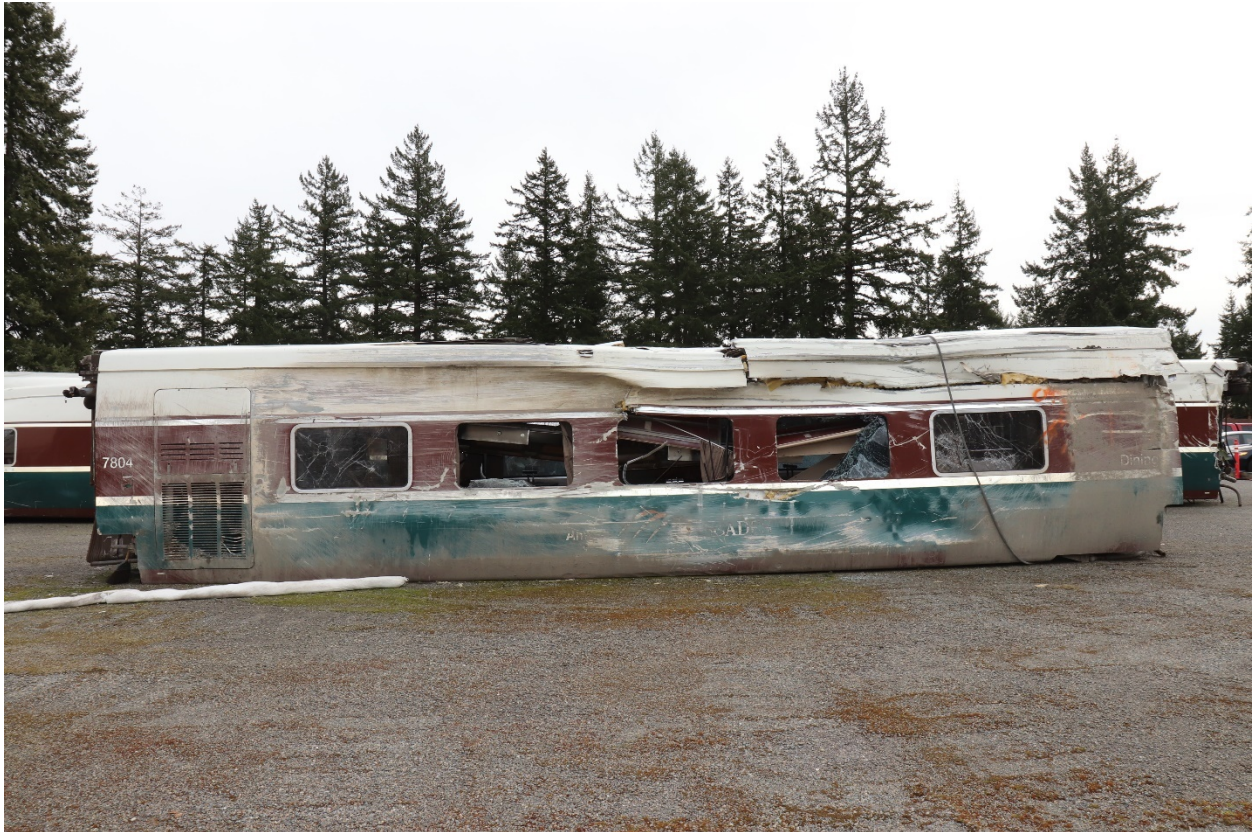
The left side wall structure was scraped and significantly deformed at the suspended end. The roof line structure along the left rear half of the car was structurally compromised and torn. Three (3) passenger windows on the left side were pushed into the passenger compartment and were shattered. The remaining two (2) exhibited indication of impacts and were shattered. Uniform witness marks were present along the left side above the window line, consistent with the raking collision from AMTK 7504. The marks were radiused and about 3/8-inches wide extending about 16-feet along the length of the car.

Figure 32. AMTK 7804 left side.

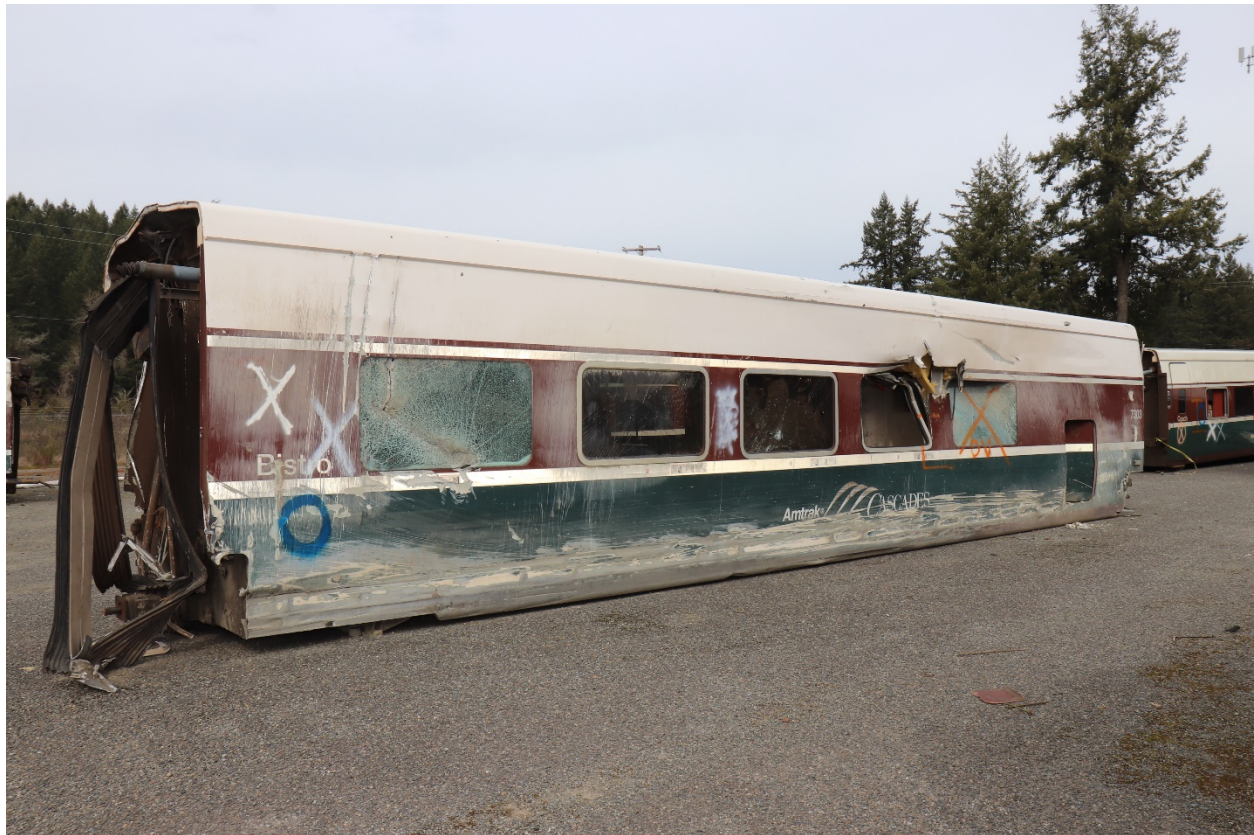
The exterior right-side was structurally intact, and the windows were in place. Two windows were shattered, and one was pushed slightly inward in an area that sustained some structural compromise. There was uniform scraping that ran the length of the side wall along the bottom, about 16-inches on average from the floor line.

Figure 33. AMTK 7303 Right side.
